Greasley Castle, Nottinghamshire: Enhanced Level 2 Historic Building Survey

Greasley Castle Farm, Church Road, Greasley,
Nottinghamshire, NG16 2AB

Dr James Wright FSA
Triskele Heritage, Sneinton, Nottinghamshire

March 2022

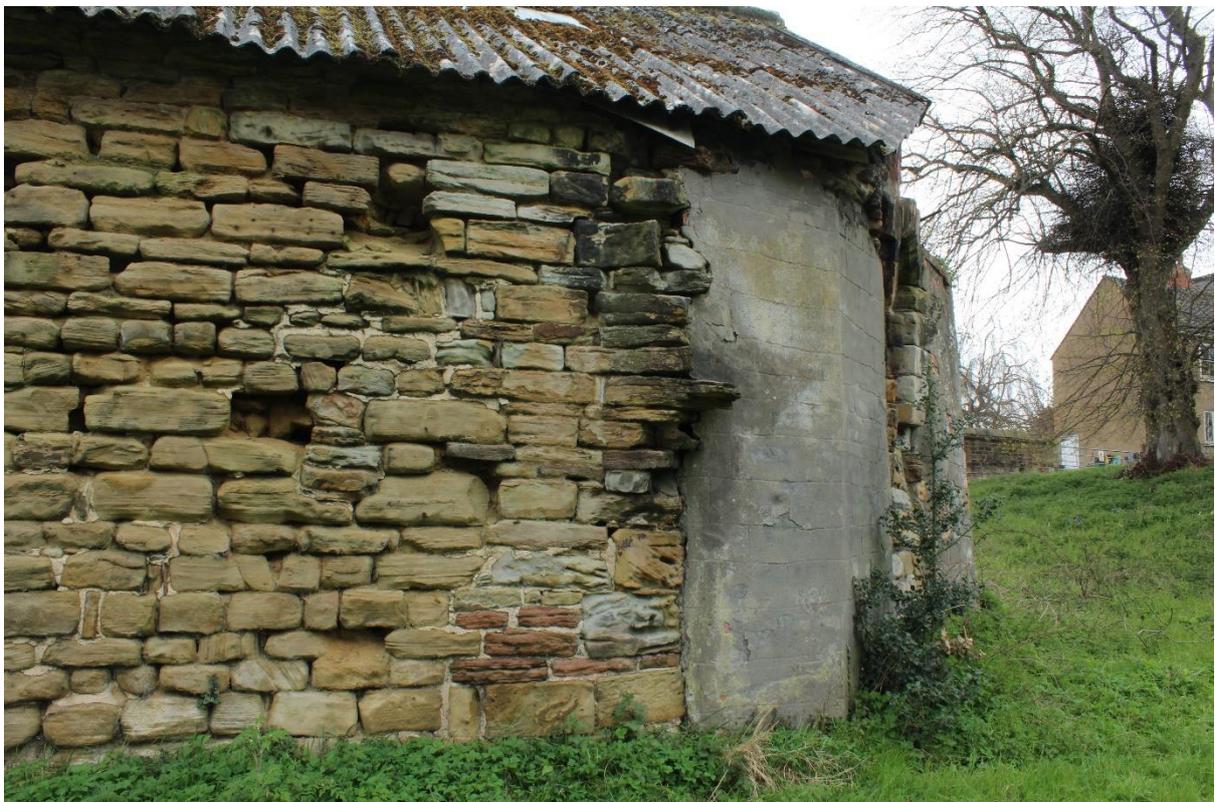
Figure 14 Projecting spur and blocked turret door at the west end of the north curtain wall, looking south-west

To the north of the wall is a dry ditch which measures approximately 11.8 metres in width (Figure 13). Projecting approximately 0.56 metres into the moat are two masonry spurs at the extreme east and west ends of the curtain (Figure 14 and Figure 18). The western spur corresponds with a similar return in the west curtain wall of the castle. The area to the north-west was excavated in 1933 and the partial foundations of a circular or polygonal turret were revealed (Green 1934, 38; Figure 15). Projections based on the buildings archaeology and excavated evidence suggests a turret of approximately 8 metres external diameter. The turret was originally accessed through a doorway, approximately 0.86 metres in width, which had a pointed arch internally and splayed chamfered jambs with a segmental rear-arch (Figure 16 and Figure 17).

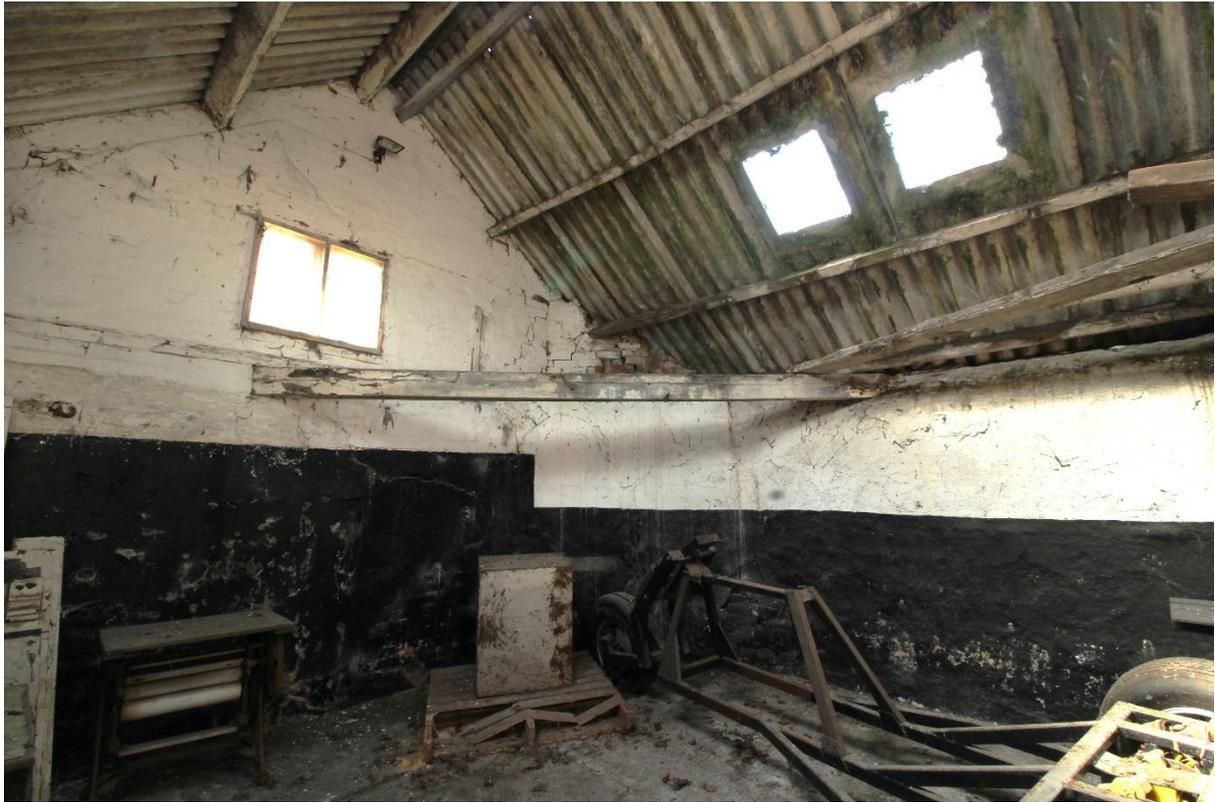
Figure 16 North-west angle of the north (right) and west (left) curtain walls, looking north-west, note the blocked door to the north-west turret

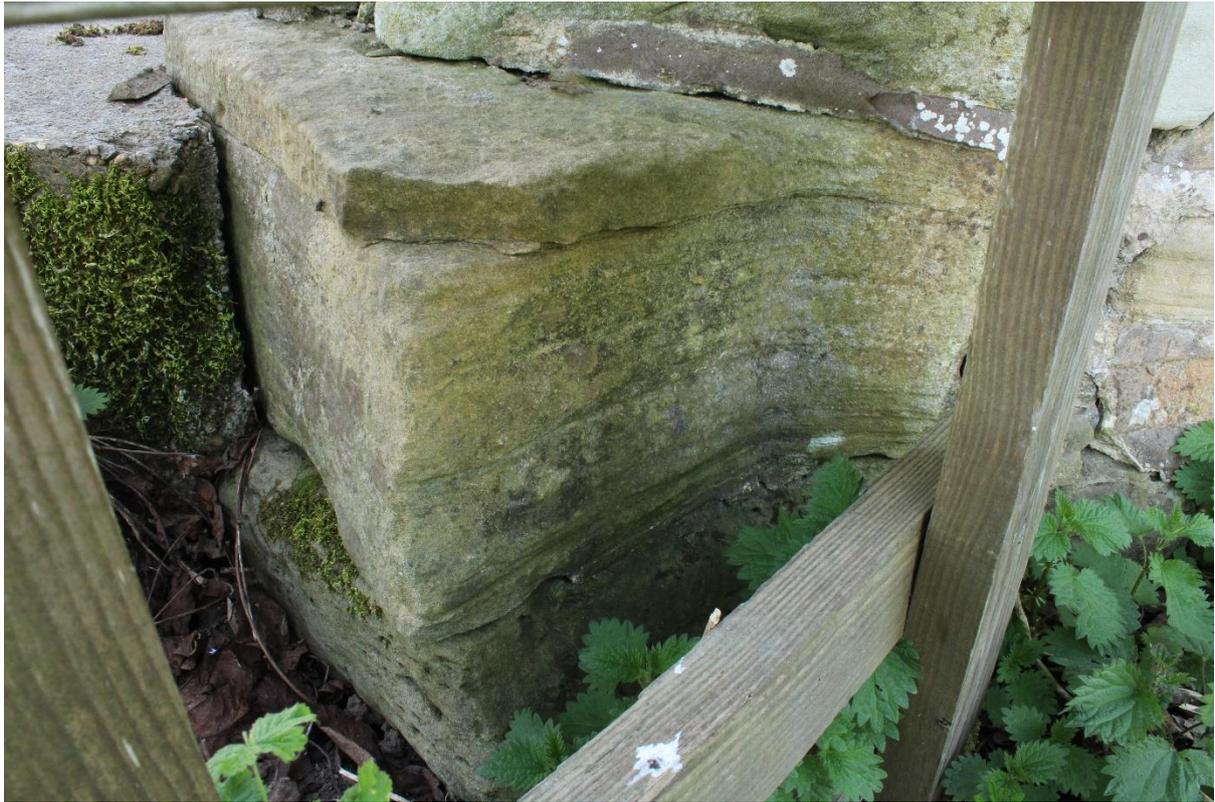
Figure 18 Projecting spur at the east end of the north curtain wall, looking south

Foundations were not encountered during the 1933 excavation at the eastern end of the curtain wall, but the projecting spur would seem to be indicative of a similar feature in this location (Green 1934, 38; Drawing 1, Figure 18 and Figure 80).

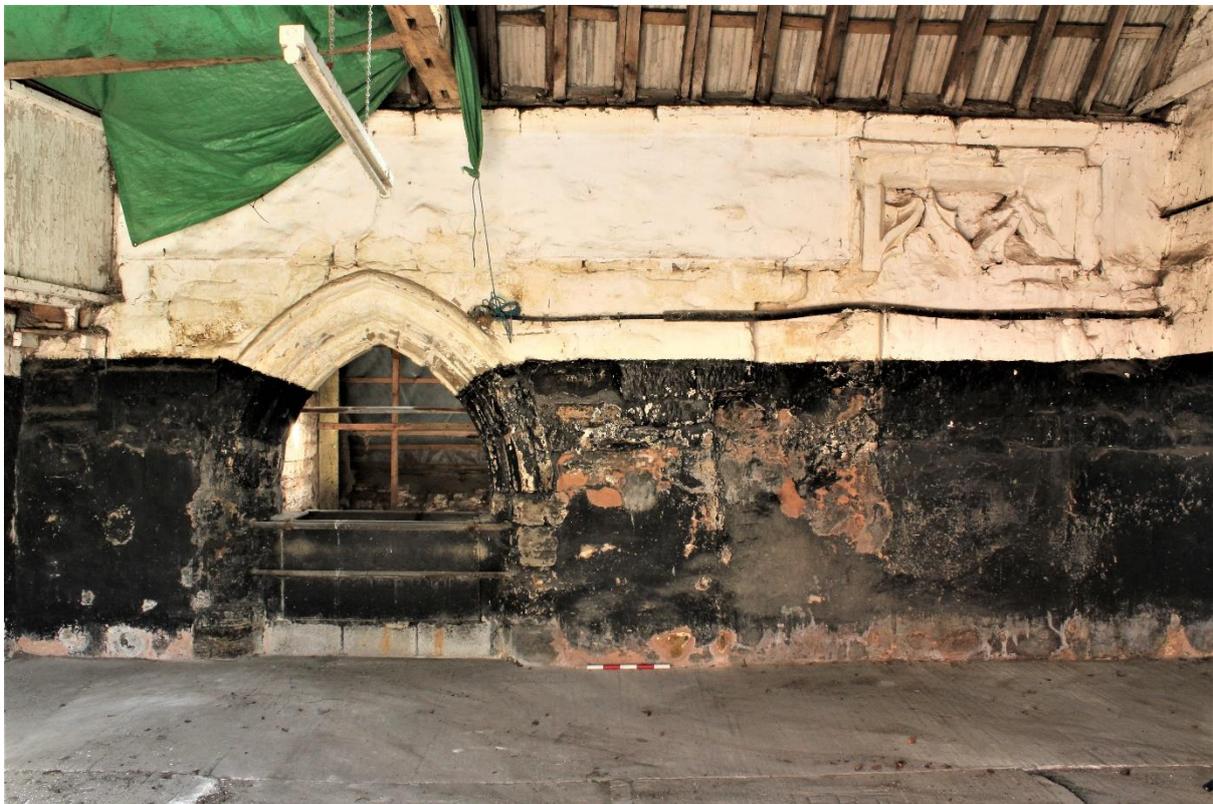
Figure 21 West elevation of the great hall, looking west, note the moulded doorway (left), blocked tracery window (right) and cornice (above)

To the south of the doorway is a blocked window - its western reveal measures 1.45 metres in width, its splayed eastern embrasure measures 1.84 metres in width and it was originally at least 2.9 metres in height (Figure 21). There is a blocked, flat-headed, two-light, tracery window head still in situ. The ogee-arched, paired lights have trefoil heads which are double-cusped. The Curvilinear Decorated Gothic style would seem to indicate a date in the mid-fourteenth century (or possibly slightly later) and bears a close resemblance to the tracery, dated c 1355, of the priest's house founded to serve Nicholas de Cantelupe's chantry chapel at Lincoln Cathedral (Figure 22). It is feasible that both windows may have been constructed by the same master builder.

A second blocked window lies approximately 3.4 metres to the south. It has a reveal which is 1.26 metres in width and an embrasure which is 1.87 metres in width (Figure 23). Empty rebates on the west elevation indicate that it probably once had a tracery window head like the one described above. Despite the missing head, there is a truncated section of chamfered transom with the springers for mullions on the upper face and the soffit. The difference in widths between the two windows may be accounted for because of significant post-mediaeval remodelling to the southern example. Above the windows and door is a chamfered cornice which probably indicates the level of the mediaeval eaves (Figure 21).

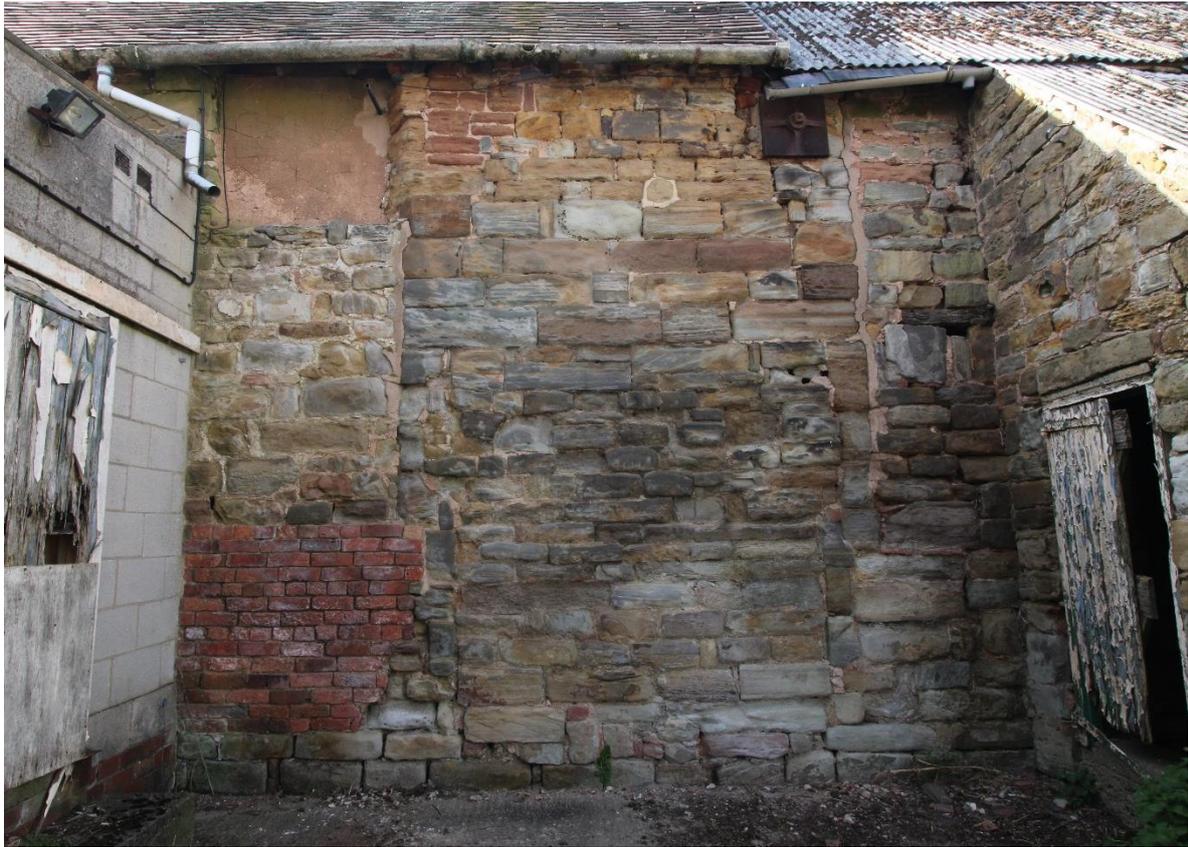
Figure 24 Detail of the east elevation of the mediaeval courtyard wall, looking west, note the straight joints of two blocked windows which flank the straight joints of a possible blocked fireplace

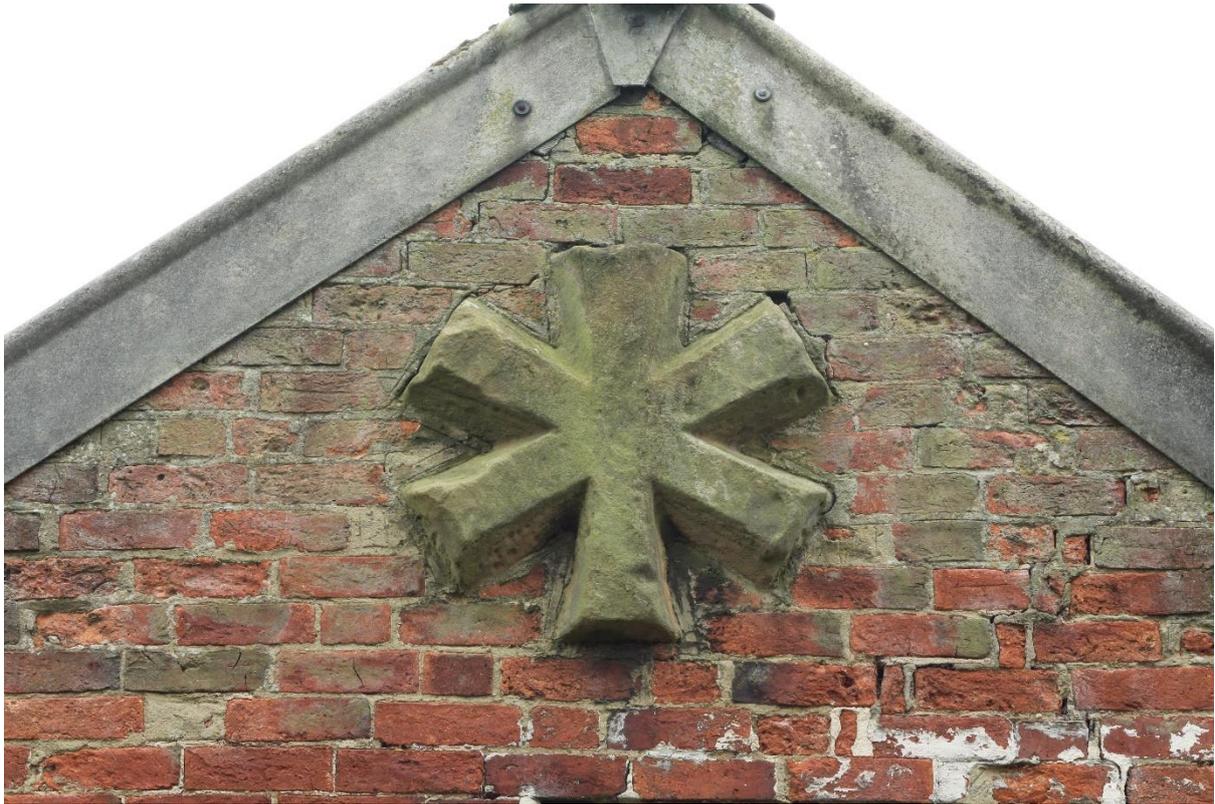
Figure 26 Crown of sexpartite vault reused in the gable of Building 8 (Ex Situ Feature Number 002), looking east

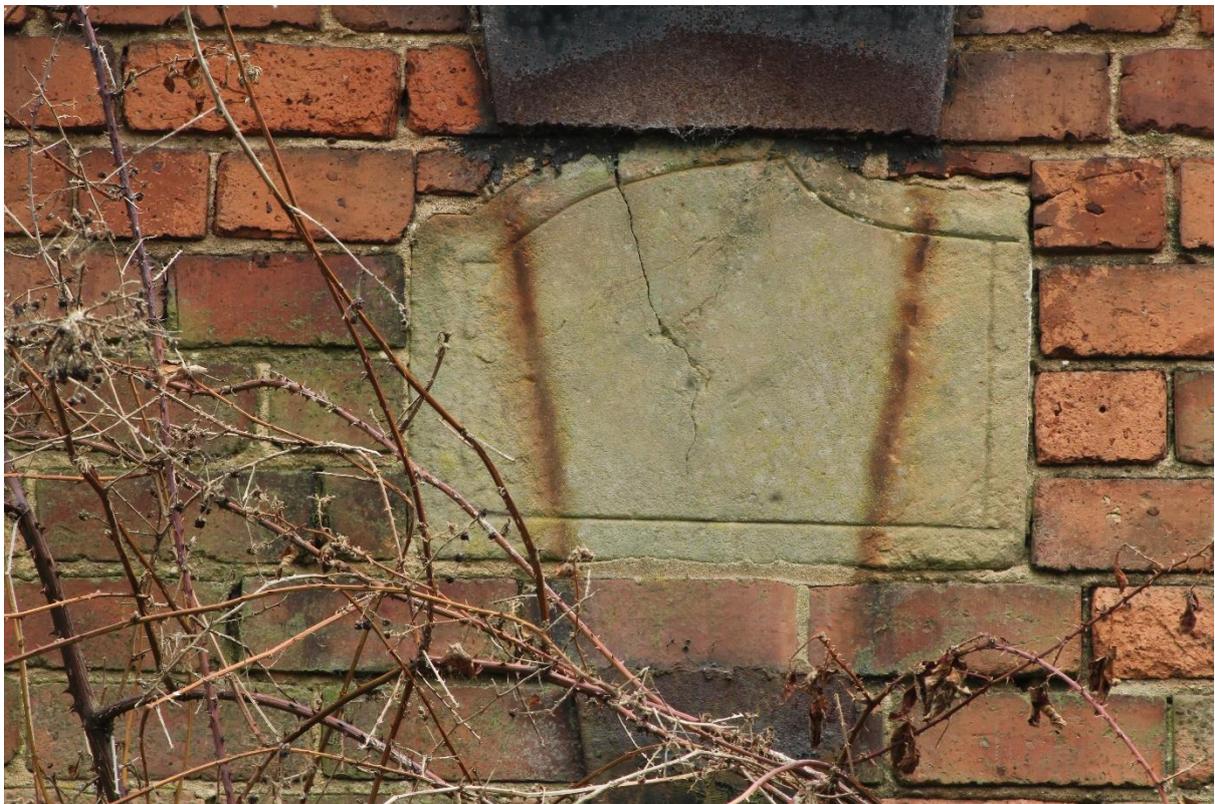
Figure 27 Rebated stone reused in Building 9 (Ex Situ Feature Number 003), looking east

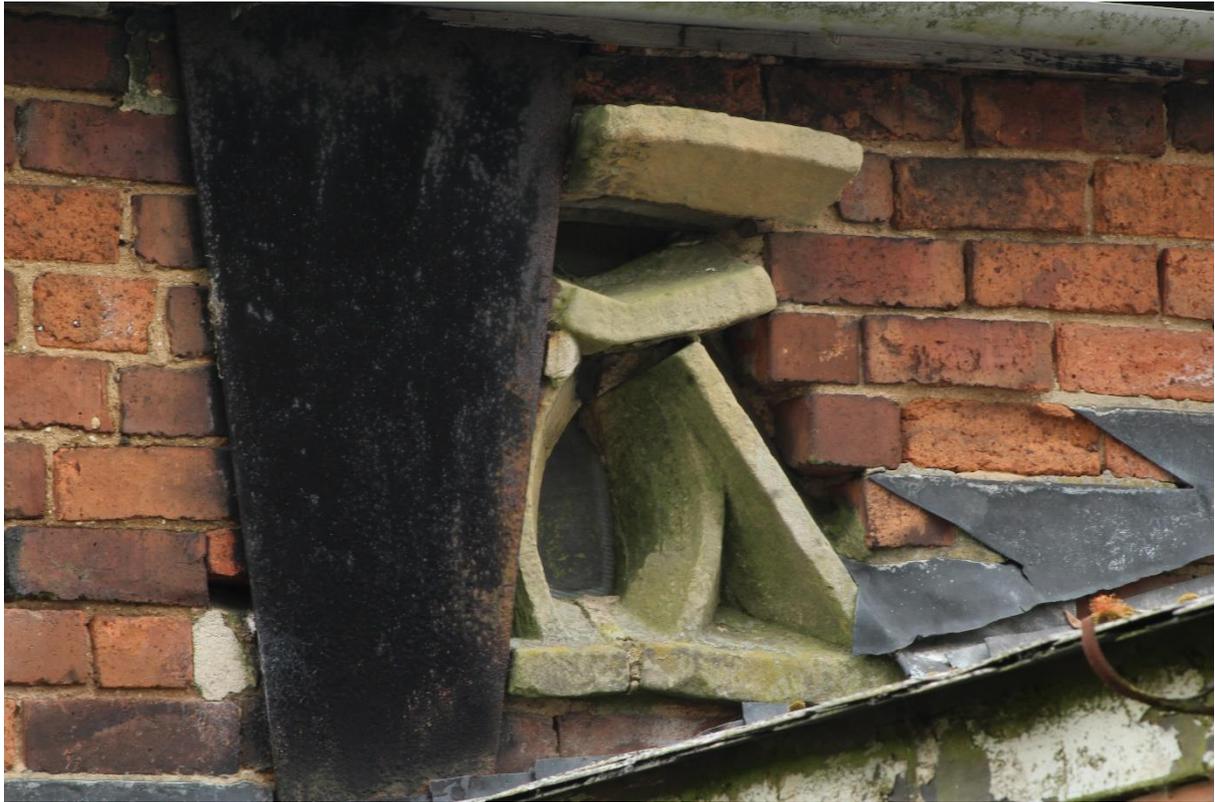
Figure 28 Four fragments of window tracery reused in Building 9 (Ex Situ Feature Number 004), looking east

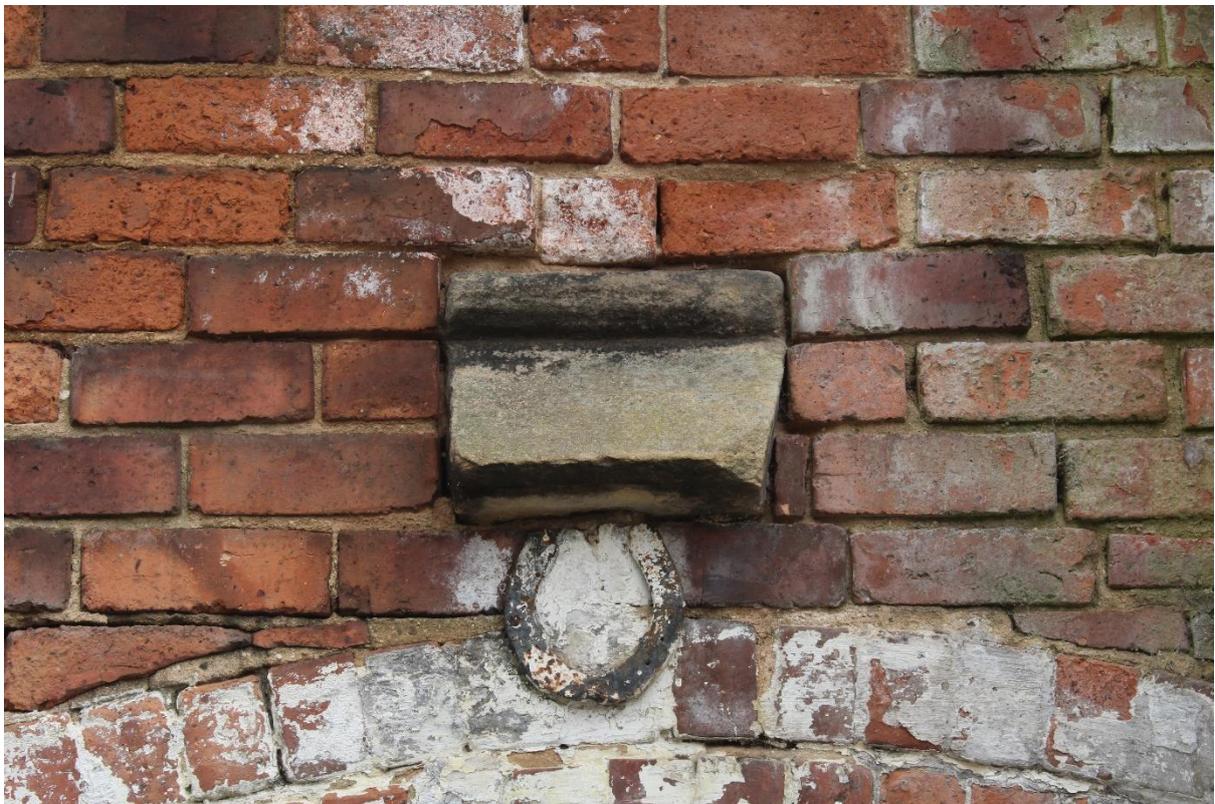
Figure 29 Moulded coping - possibly from a merlon - reused above the west farmyard entrance (Ex Situ Feature Number 005), looking east

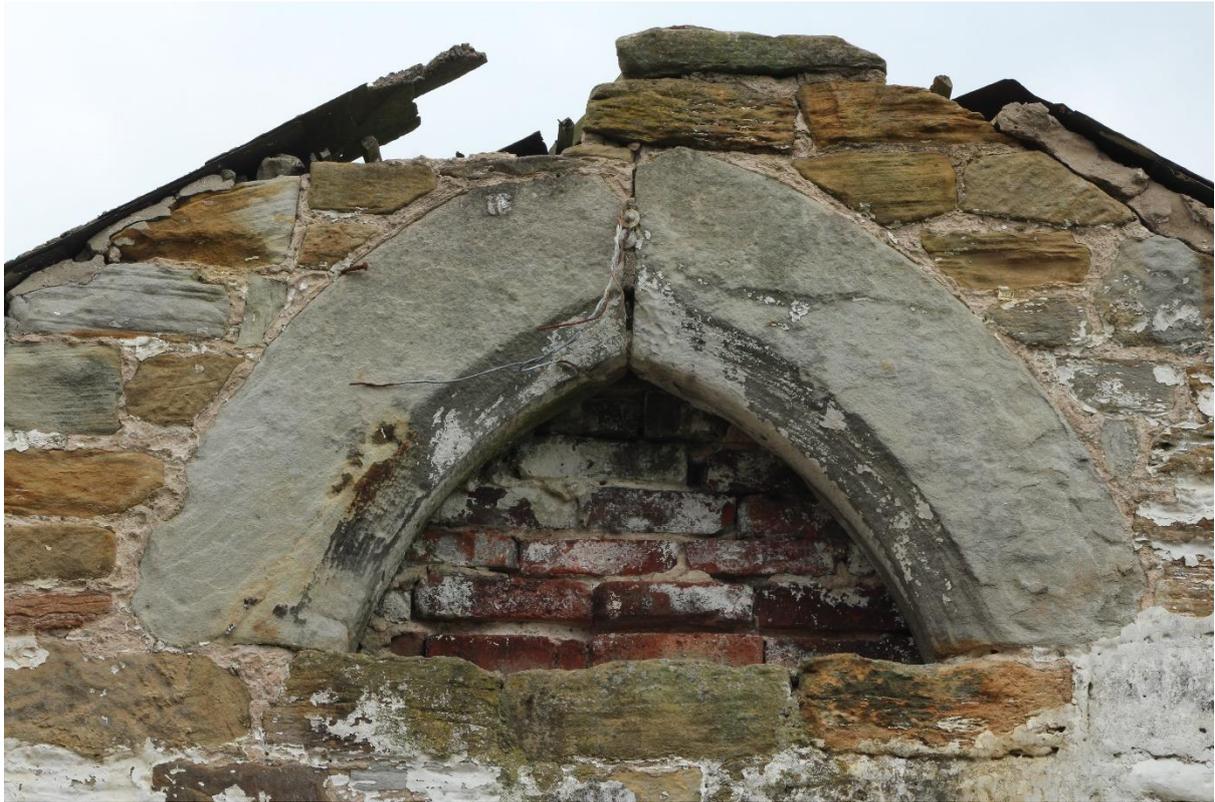
Figure 30 Chamfered door crown reused in the south gable of Building 4 (Ex Situ Feature Number 006), looking north

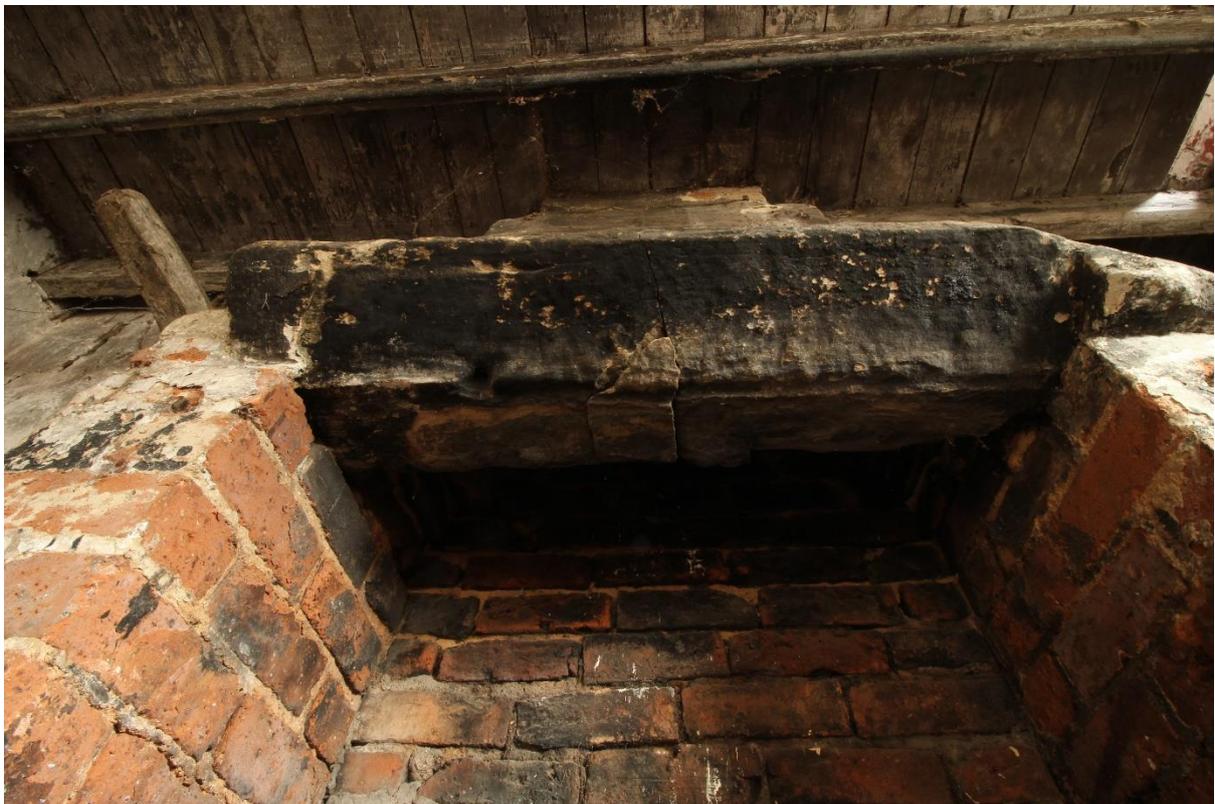
Figure 31 Window jamb reused as a chimneypiece in Building 9 (Ex Situ Feature Number 007), looking north

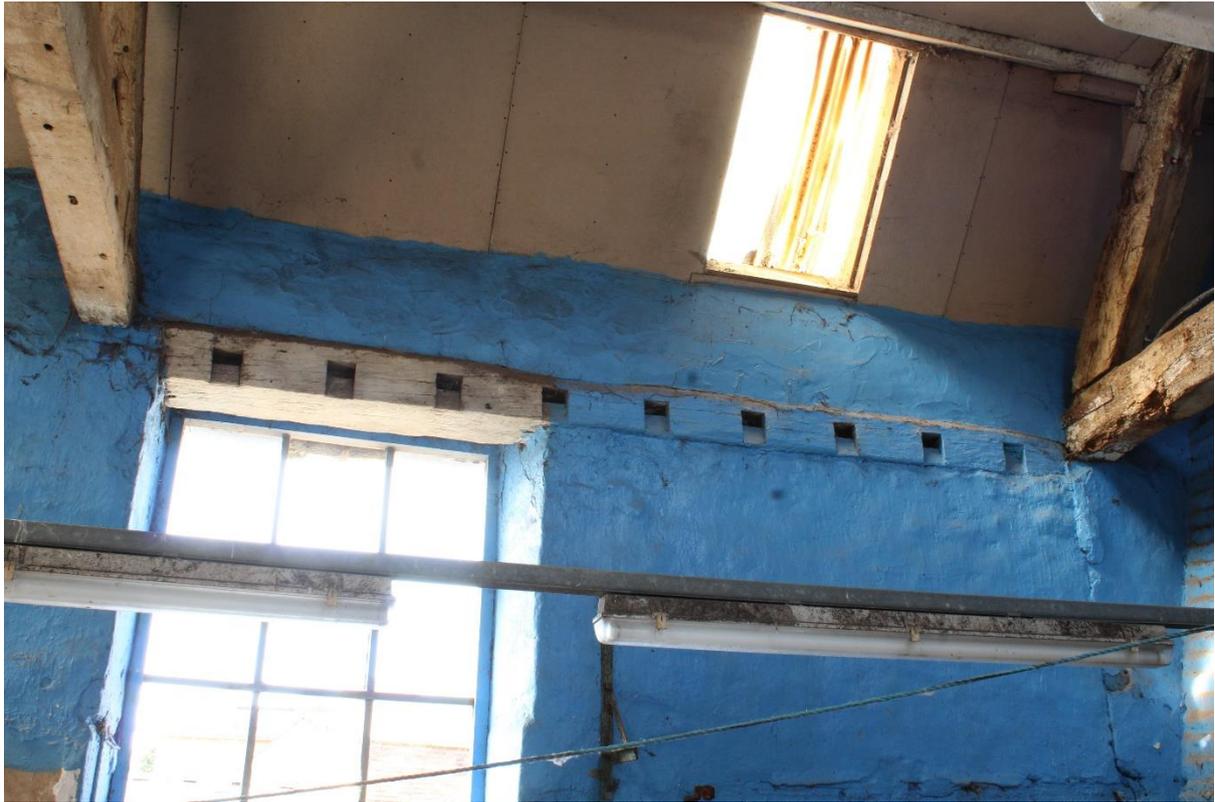
Figure 34 Floor beam reused as a window lintel in Building 5 (Ex Situ Feature Number 010), looking west

Feature Number	Description	Location	Figure Number
010	Beam from floor frame	Reused as a window lintel in west elevation of Building 5	Figure 34
011	3 timbers with relict mortises and peg holes	Reused as tie beam and rafters of Principal Truss 1 in Building 5. West rafter possibly contains 5 apotropaic burn marks on south face.	Figure 35 Figure 36
012	3 timbers with relict mortises and peg holes	Reused as tie beam and rafters of Principal Truss 3 in Building 5, tie beam was possibly once a cill beam	Figure 37
013	3 timbers with relict mortises and peg holes	Reused as tie beam and rafters of Principal Truss 4 in Building 5, tie beam was possibly once a bridging beam with stud wall. East rafter contains 5 possible apotropaic burn marks on soffit.	Figure 38 Figure 39
014	3 timbers with relict mortises and peg holes	Reused as tie beam, west rafter and collar	Figure 40

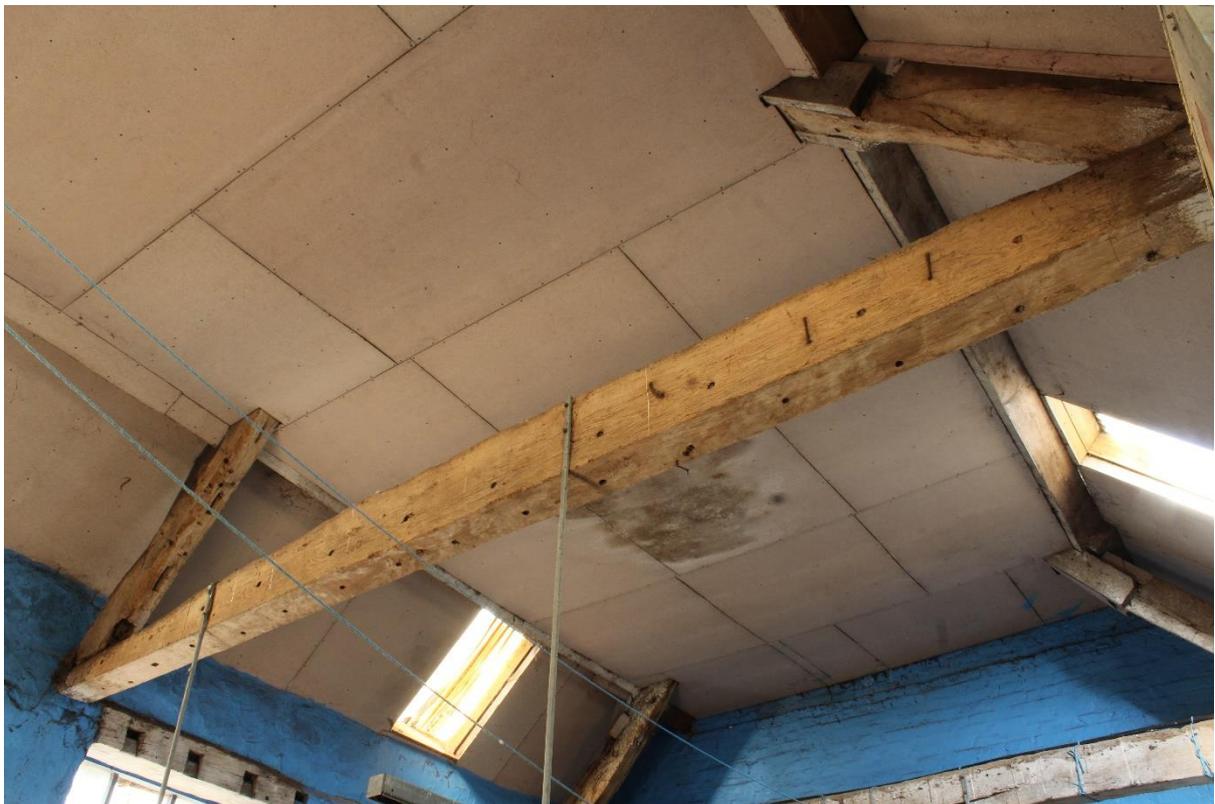
Figure 35 Reused timbers in Principal Truss 1, Building 5 (Ex Situ Feature Number 011), looking north-west

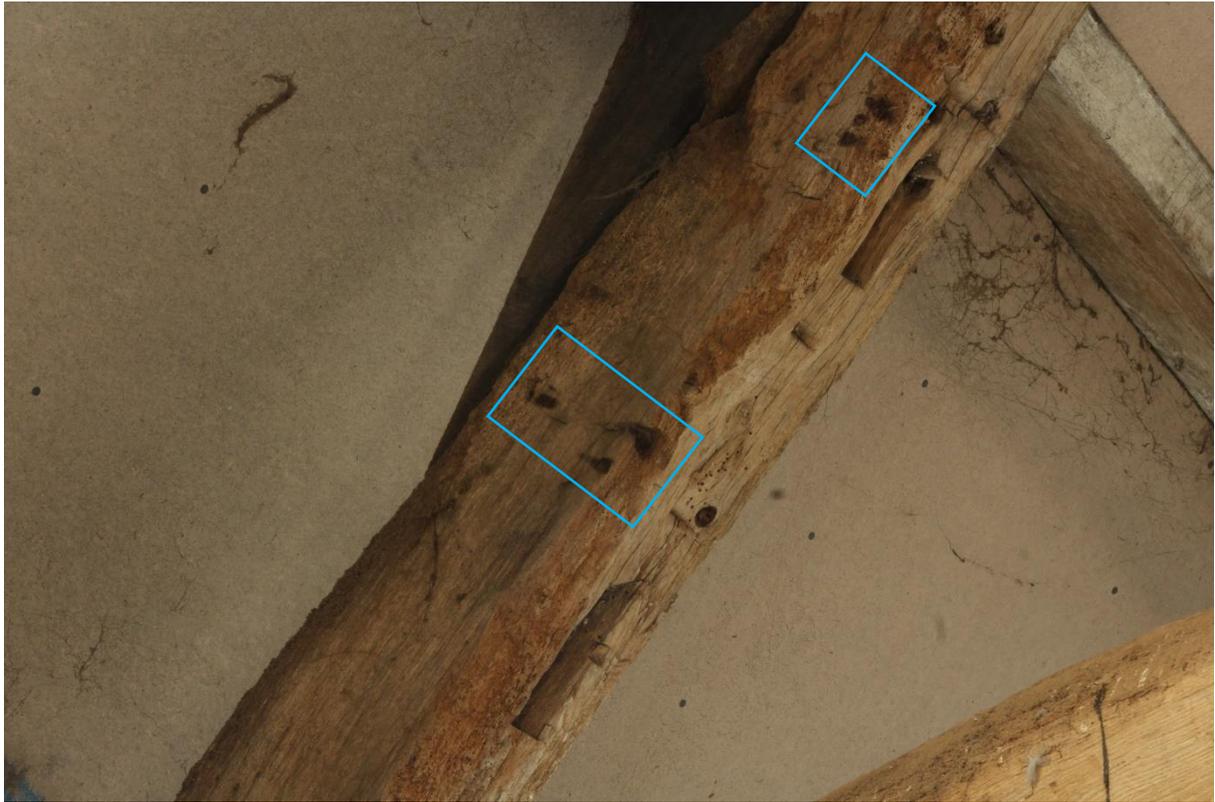
Figure 36 Possible apotropaic burn marks (outlined in blue) on north face of west rafter of Principal Truss 1, Building 5 (Ex Situ Feature Number 011), looking north-west

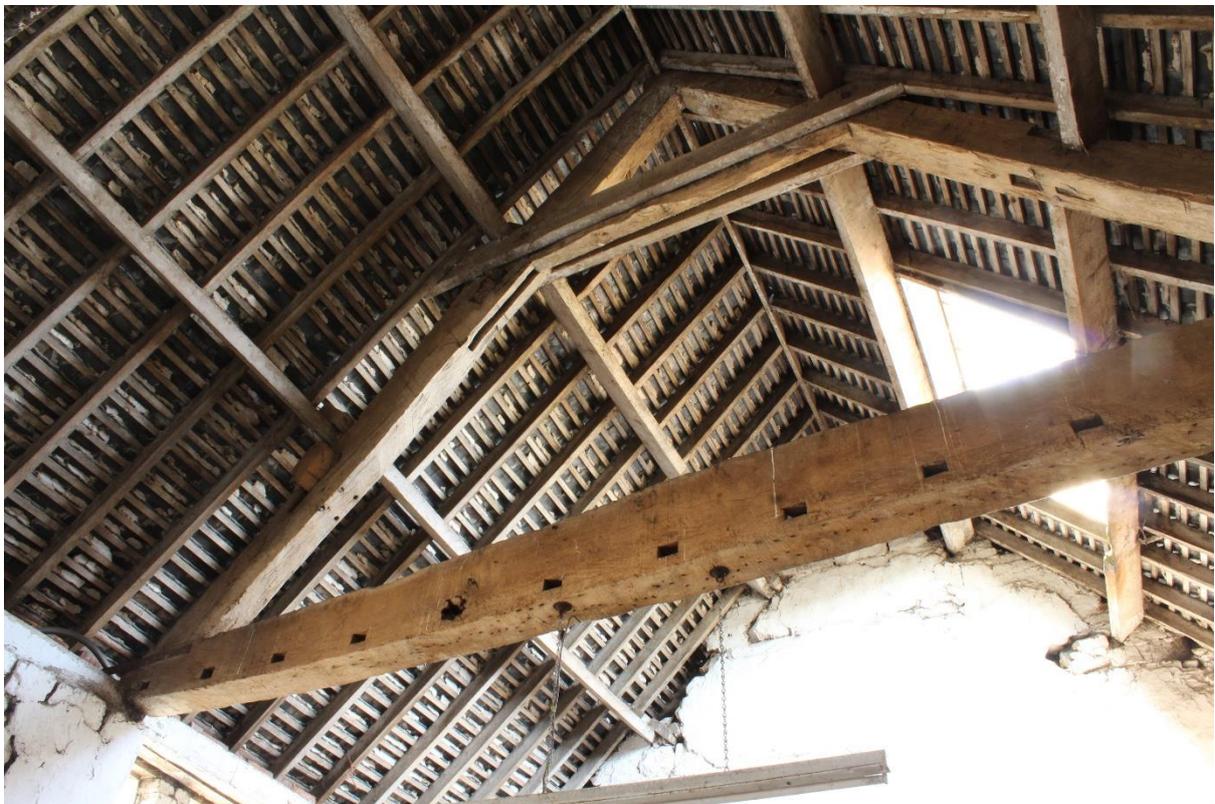
Figure 37 Reused timbers in Principal Truss 3, Building 5 (Ex Situ Feature Number 012), looking north

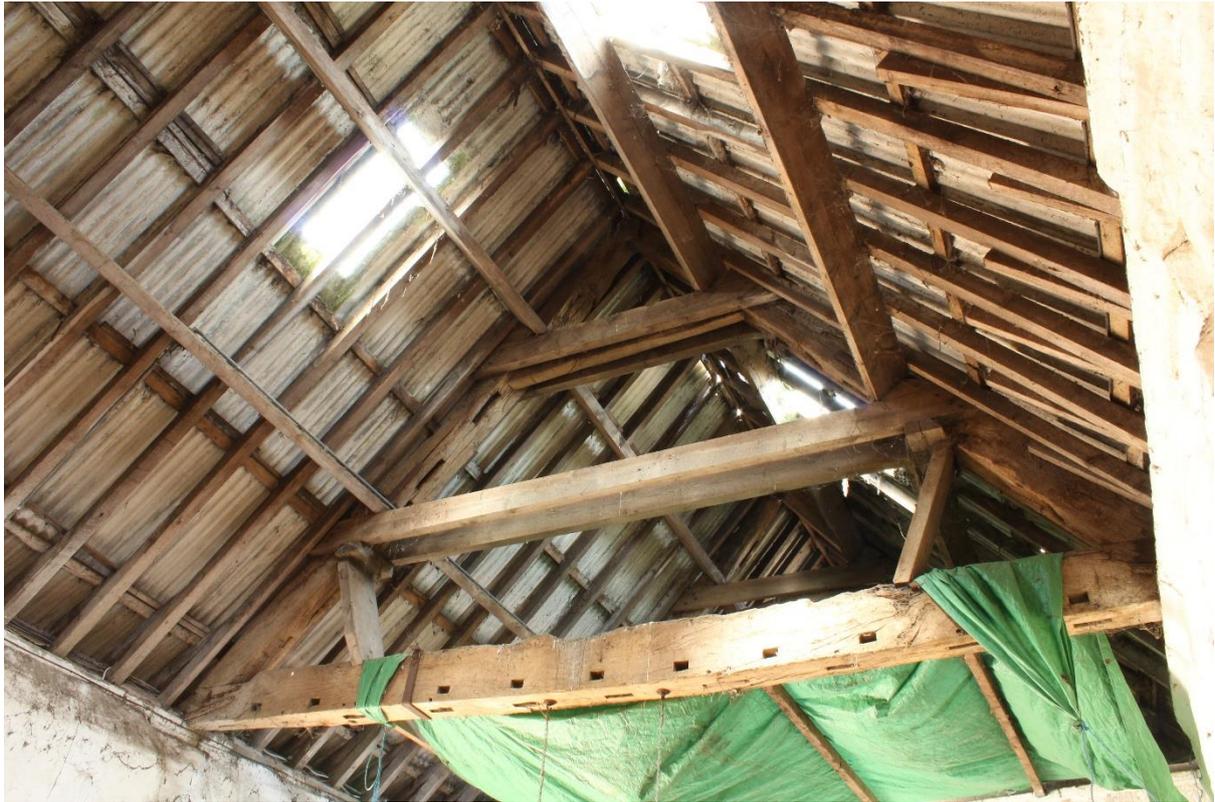
Figure 38 Reused timbers in Principal Truss 4, Building 5 (Ex Situ Feature Number 013), looking north

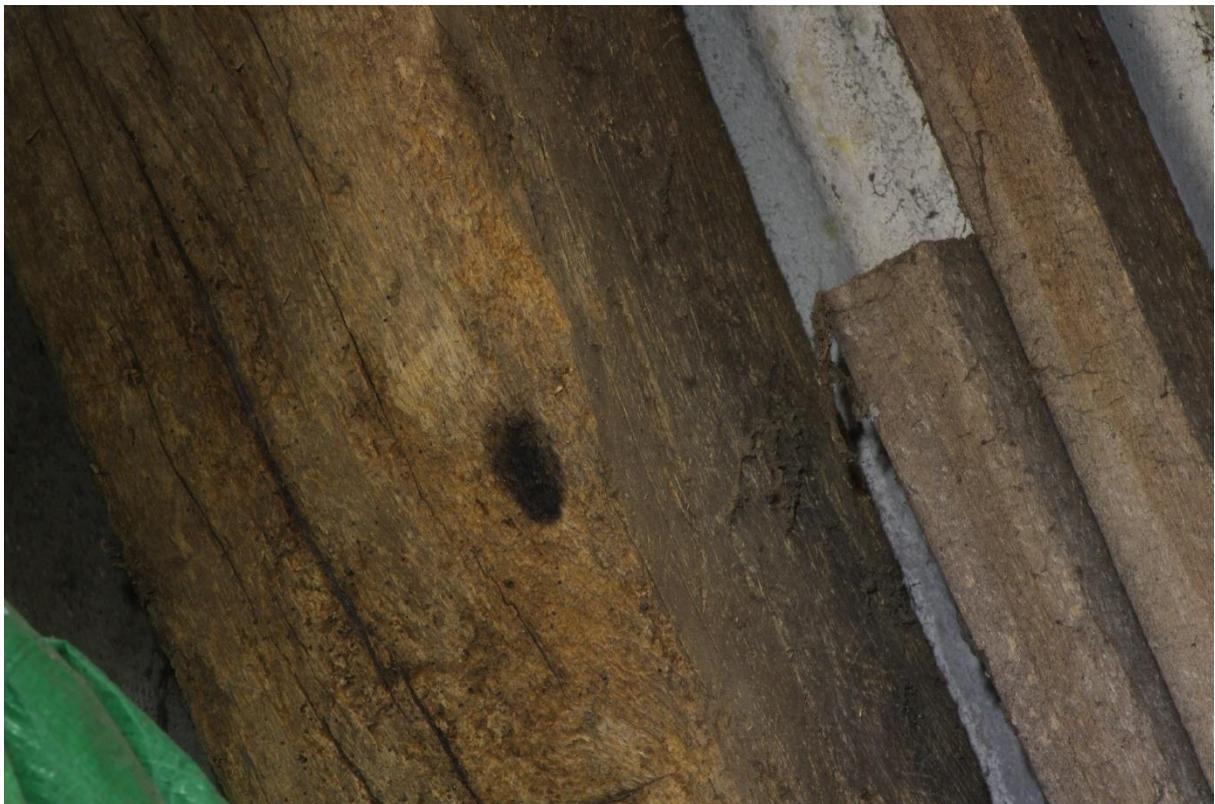
Figure 39 Possible apotropaic burn mark on the soffit of east rafter of Principal Truss 4, Building 5 (Ex Situ Feature Number 013), looking north-east

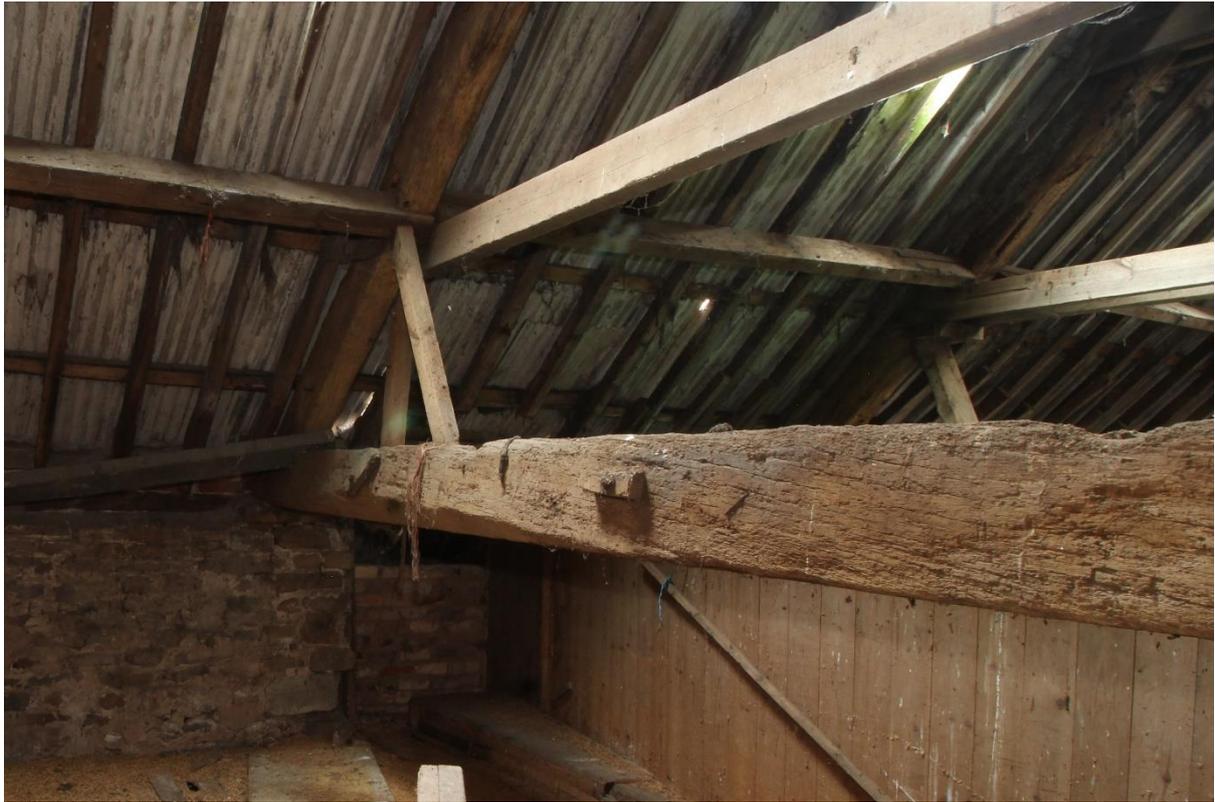
Figure 40 Reused timbers in Principal Truss 5, Building 5 (Ex Situ Feature Number 014), looking south-east

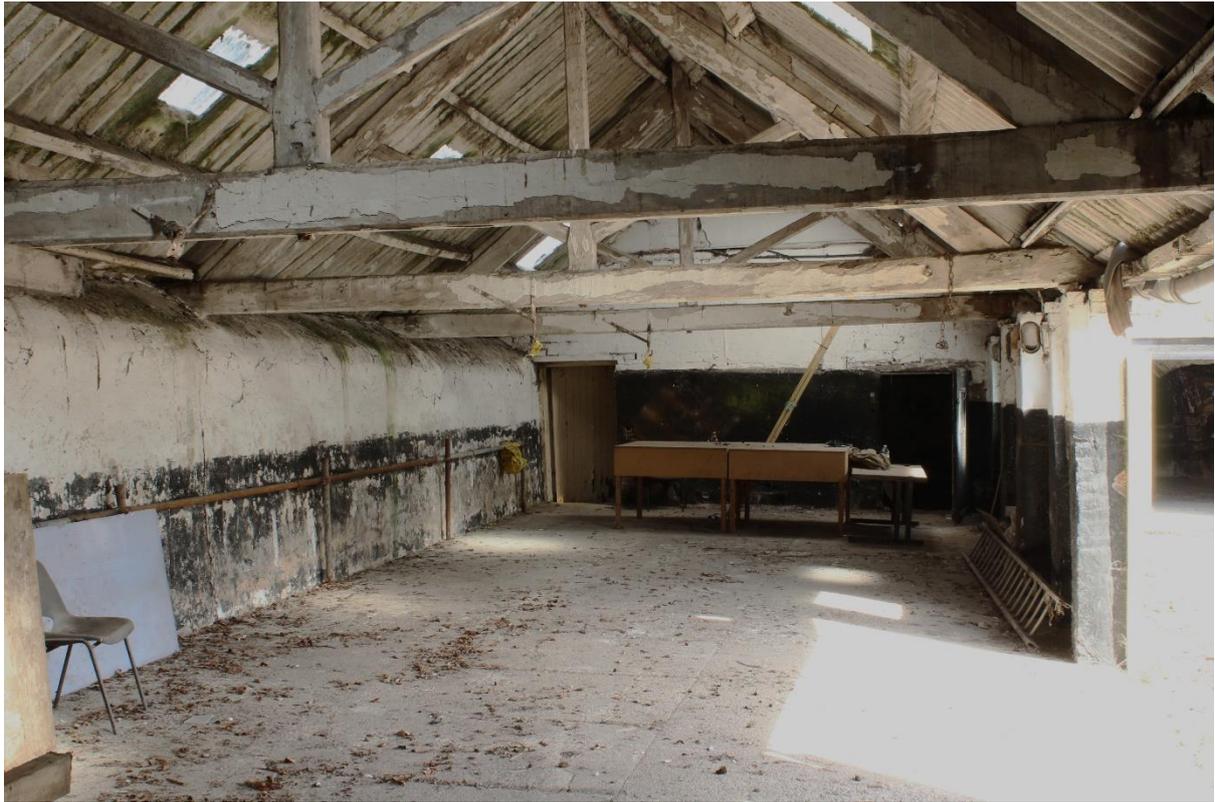
Figure 46 Interior of Building 8, looking east

As noted above, Building 5 was also remodelled during Phase 3. It may have had two doors and two high-level windows inserted through its west elevation as they have segmental arches and mullions which match the brickwork of the new farmyard buildings discussed above (Figure 43). Internally, the transverse brick wall to the north of the modern animal dipping pool (Figure 45), the transverse wall to the north of the farmyard doorway and the northern gable end (Figure 12) are also of similar brickwork. The east elevation masonry of the through-passage at the north end of Building 5 also seems to have been remodelled to include a ledge above the eastern doorway (Figure 19). The doors to the eastern yard and into Building 8 are all nineteenth century in date and have mass-produced strap hinges (Figure 19, Figure 46 and Figure 83).

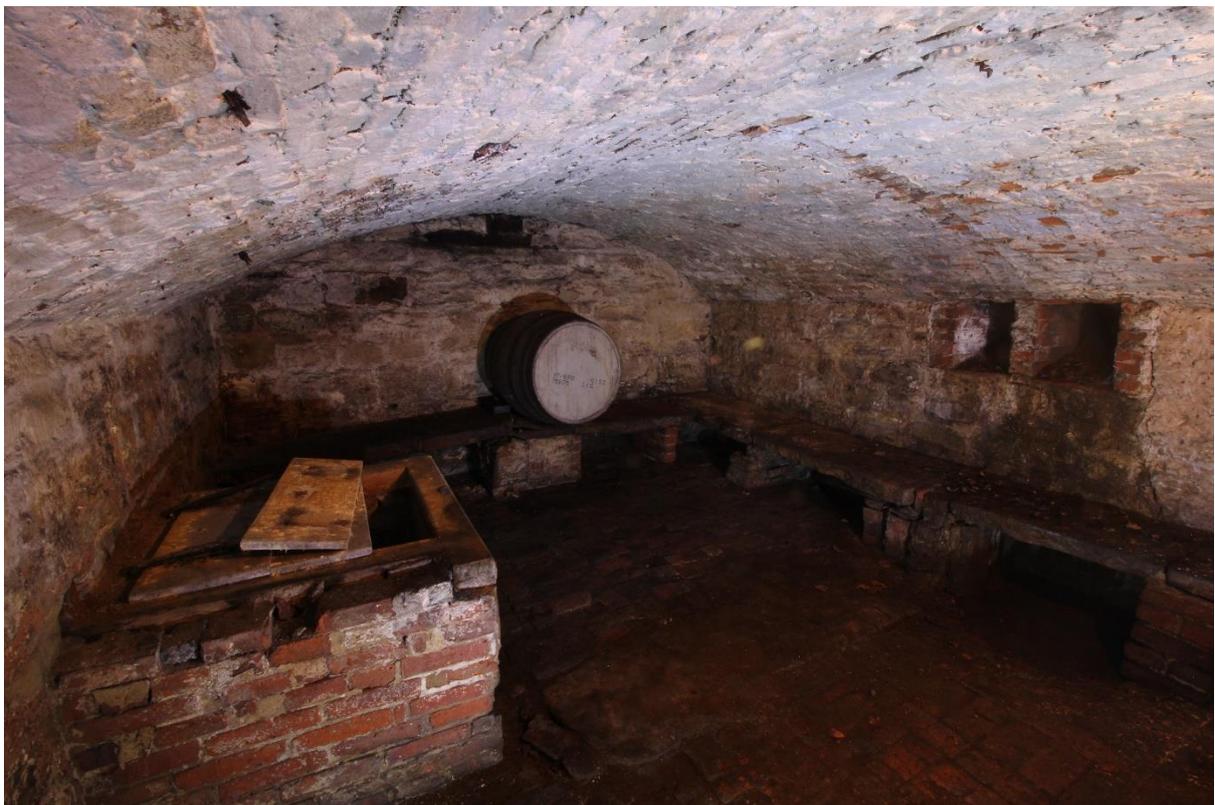
Figure 55 Cellar in the north-west corner of the farmhouse, looking south-west

The farmhouse has a small single room cellar underneath what is now the ground floor dining room in the north-west corner of the building. It has a brick floor and a brick vault. The brickwork measures 107mm (breadth) by 52mm (thickness) by 232mm (length). The walls are of coursed stone. It is possible that the brick vault replaced an earlier timber floor and was inserted during the eighteenth-century remodelling to the house. The cellar has a blocked double coal chute through the west elevation which is lined in brick. A stone slab stillage lines the west, south and part of the north elevations.

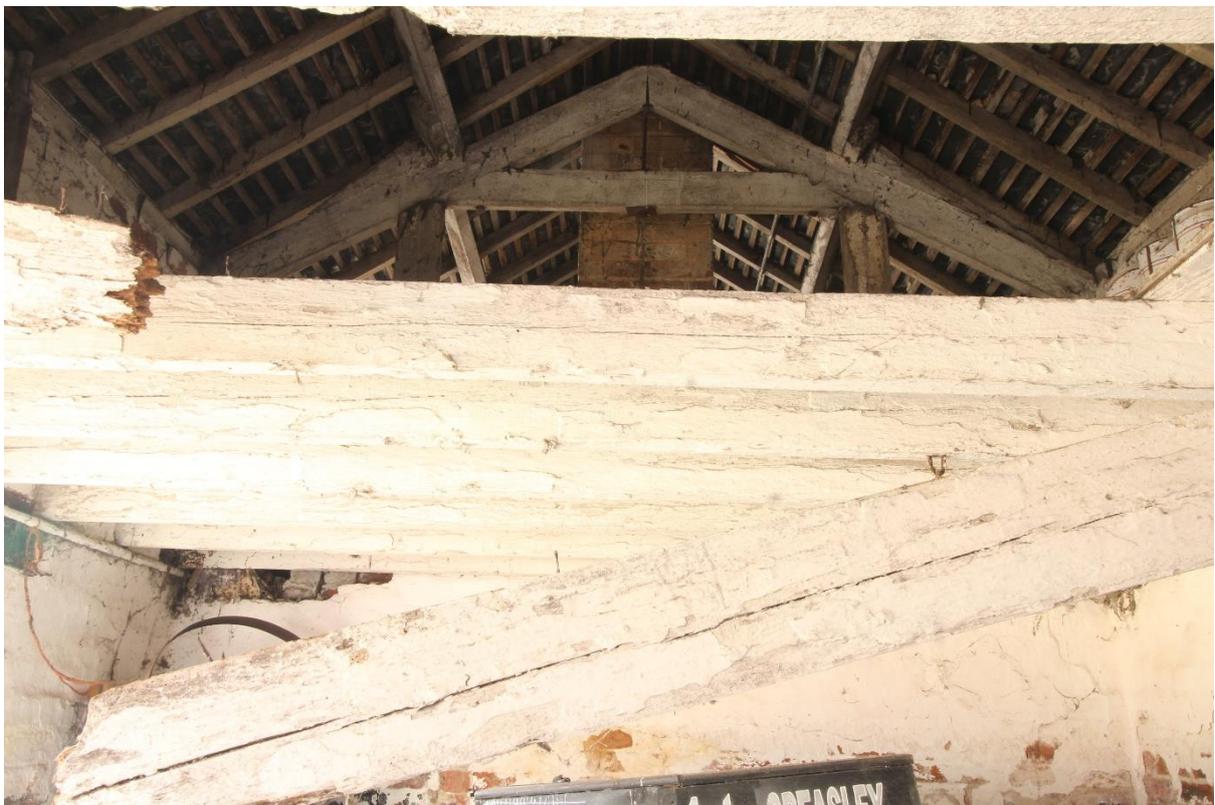
Figure 91 Queen post roof of Building 9, looking south

The two-storey southern bays were added at a point between 1880 and 1900 (Phase 3b; Figure 10 and Figure 82) and were block bonded to the Phase 3a range to the north. Only the ground floor was observed during the survey. The brickwork of the Phase 3b addition measures 106mm (breadth) by 75mm (thickness) by 229mm (length). The central bay of Building 9 is a storeroom accessed via a wide, modern doorway with a rolled steel joist lintel. This door replaced an older door which probably had a timber lintel. Above is a small loop window with a segmental arched head. The store has a modern concrete floor and east-west orientated joists supporting the upper floor. To the south is another storeroom, accessed from the south, which was formerly a workshop with a brick floor (Figure 90). This space may once have had a residential function as it contains a brick fireplace with a reused window jamb for a lintel in the north elevation (Figure 31). There are two square recesses flanking the fireplace. The room is lit by a segmental arched window in the east elevation. It has east-west orientated joists supporting an upper floor lit by a three-light window with a timber frame. The roof structure of Building 9 is a queen post design (Figure 91).
